Draycott Conservation Area Character Appraisal

**Adopted
July 2013**

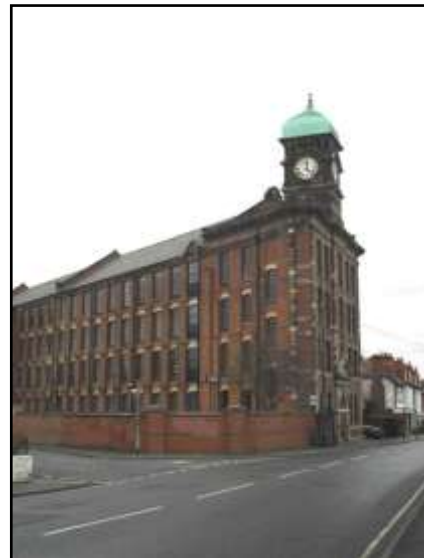
2.8 The historic village is bounded on its east side by the grade II listed Victoria Mill (pictured) and contemporary speculative housing. This area has been identified informally as having some special architectural or historic interest. The Council may pursue the formal designation of this area as a separate exercise.

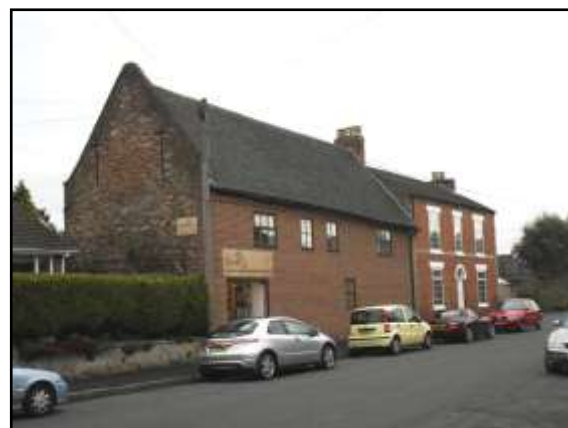
3.15 Two surviving seventeenth century buildings have been identified – a former barn (now the Beetroot Tree Gallery, pictured) and the so-called Manor House. They are characterised by their steeply pitched roofs with gable parapets.

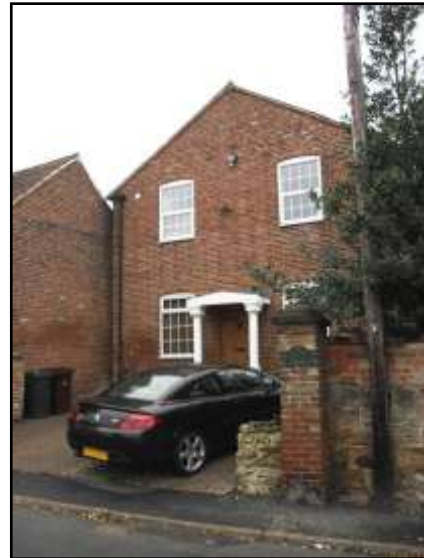
- 3.18 The rise of stocking manufacture was accompanied by the rise of Methodist worship. The first chapel was built on Lodge Street in 1800 (pictured). A larger chapel was built on Victoria Road in 1830, at which time the earlier chapel became a Sunday school.

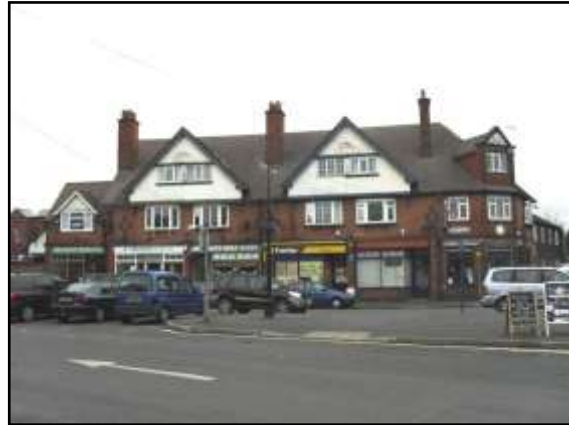
- 3.23 A terrace of shops on the corner of Market Street and Derby Road, addressing the “market place”, was built in 1891 (pictured). There is an “H” in the corner gable of the terrace, which suggests that it was built for the Earl of Harrington.

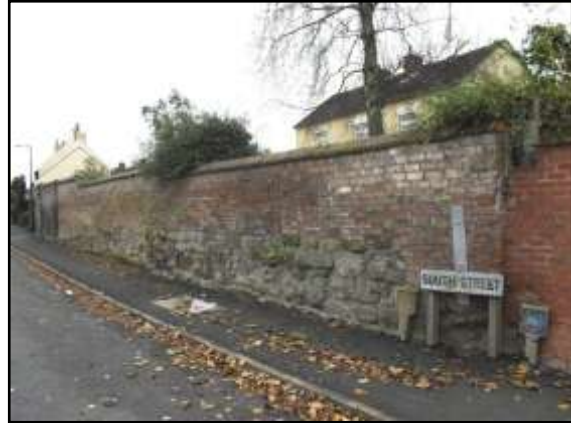
- 5.5 Because of the lesser density of this character zone and the way in which many buildings are set back from the street, boundary walls and soft landscaping make an important contribution to the character of the area. The most distinctive boundary walls are built of red brick on a substantial rubble stone plinth.

Examples can be seen in front of Bower House (pictured) and to the side of 46 South Street.

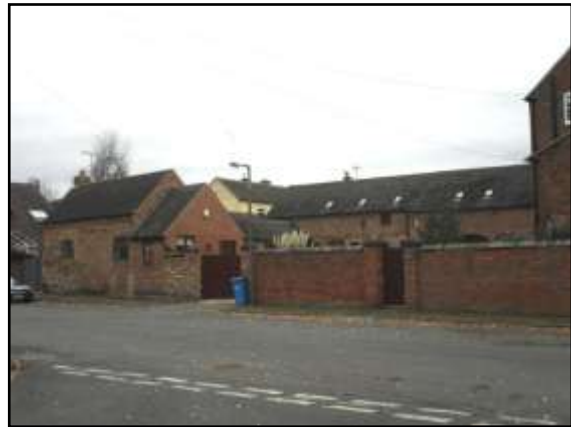
- 5.16 Cedars Farmhouse (81 Market Street) is a grade II listed building. In 2003 the associated farm buildings were converted into dwellings and these dwellings do not form part of the curtilage of the listed building. Some permitted development rights have been removed from these dwellings to ensure that their special character is sustained (see picture).

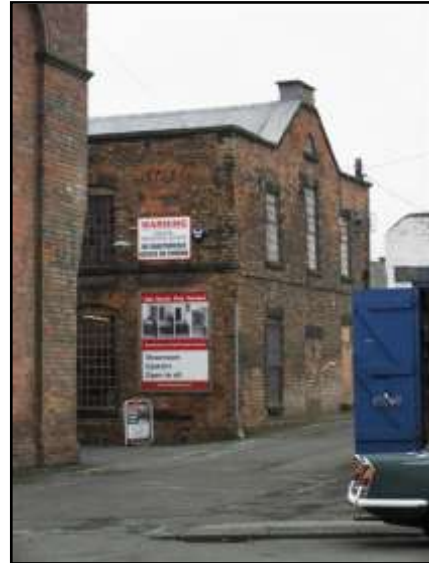
6.6 The majority of buildings in this character zone are built of red brick with natural slate roofs. Some of the slate roofs at Draycott Mills have been “turnerised”⁷ (see picture) or replaced with corrugated sheets. Both of these interventions harm the special character of the area.

- 9.9 Some of the slate roofs at Draycott Mills have been “turnerised” or replaced with corrugated sheets. Both of these interventions harm the special character of the area. Where opportunities arise, consideration should be given to the reinstatement of traditional slate roof coverings.

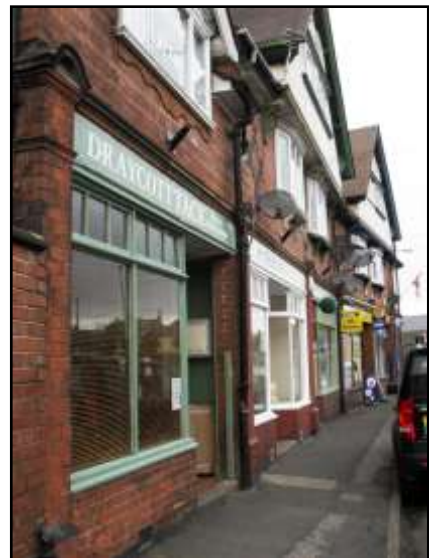
6.10 The terrace of shops addressing the west side of the “market place” has a remarkable ground floor elevation that retains an unbroken series of original painted timber shop fronts (pictured).

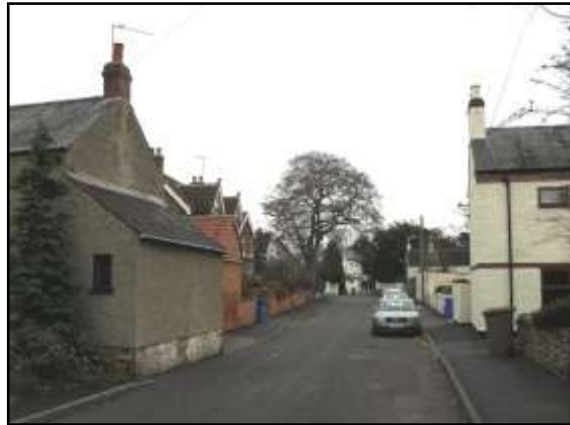
7.1 Walking east along South Street, the curve of the road reveals a view of Draycott Lodge. It is an intimate view, framed by the gables of 18 South Street and 1 Gillivers Gardens. It encompasses the large beech tree outside 6 South Street and the garden elevation of Croft Cottage. It is terminated by the garden elevation of Draycott Lodge, which is seen obliquely, and the mature trees beyond.

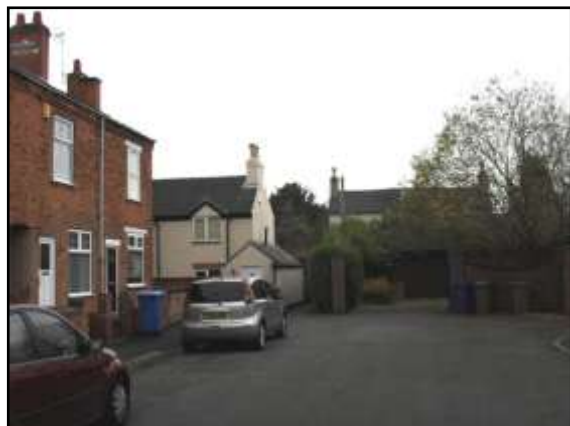
7.3 The houses on Victoria Avenue were built in the early twentieth century. However, the view south along the avenue is terminated by the rear elevations of much earlier houses (Plum Tree House and Holly Cottage). This surprising view is enhanced by the soft landscaped forecourt of 18 Victoria Avenue. It provides the sense of an “entrance” into an area with a special character.

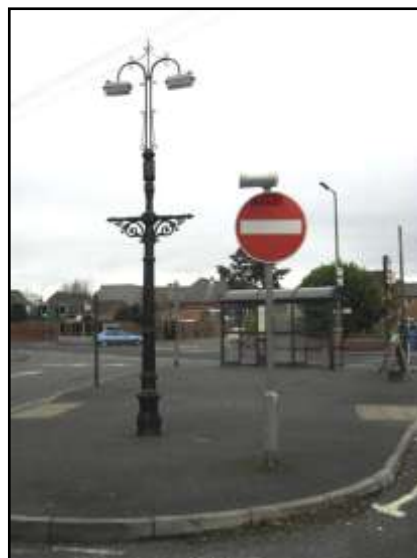
- The highly decorative lamp column on the “market place” (pictured);
- The late nineteenth century ventilation shaft by Walter MacFarlane & Co, adjacent to 1 Lodge Street.

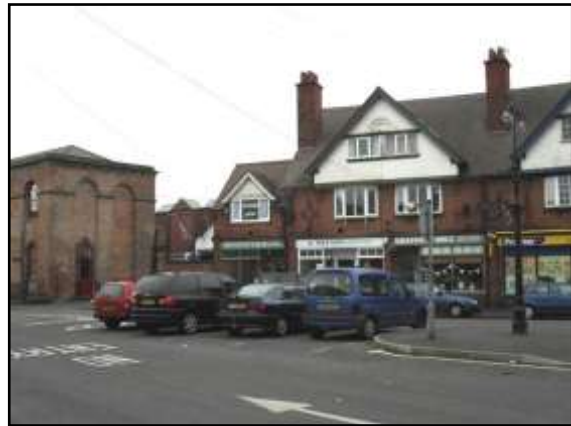
- 9.2 Car parking on the “market place” contributes to the commercial success of the village, but it does not contribute to Draycott’s special character and pedestrian enjoyment of the space is limited.

- 9.3 Consideration should be given toward ways of increasing pedestrian enjoyment of the “market place”. Any alteration to the layout and landscaping of the “market place” ought to enhance the setting of the commercial buildings that bound it and the lamp column at its centre.

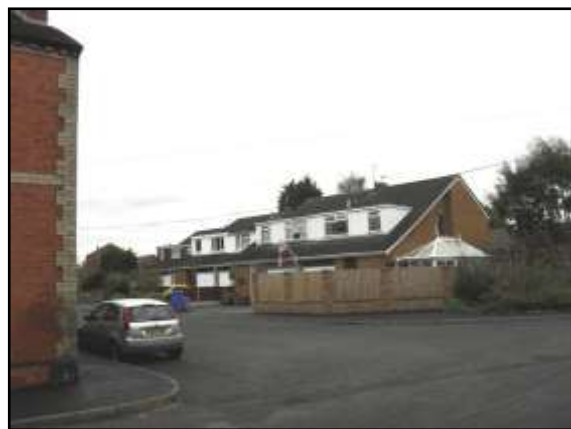
- 9.6 The group of semi-detached houses on the east side of Walk Close and the nearby group of three detached houses on the south side of South Street have buff brick walls and concrete tile roofs. The concentrated use of non-traditional building materials in this location harms the special character of the area.

- 9.7 The contribution that these modern buildings make to the character of the conservation area would be enhanced through a more consistent and sympathetic treatment of the following elements, as opportunities arise:

- Boundary treatments;
 - Window and door openings;
 - Cladding materials (e.g. for flat-roofed dormers).
- 9.8 The elimination of clutter such as soil ventilation pipes would also enhance the contribution that these buildings make.
